Asbestos Inspection Report

Courthouse
113 East Beverley Street
Staunton, Virginia

City of Staunton
P.O. Box 58
Staunton, Virginia 24402-0058

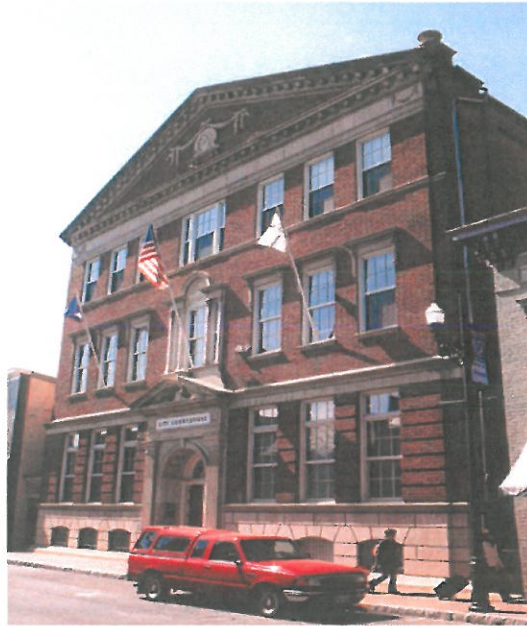
**Courthouse
113 East Beverley Street
Staunton, VA**

NONE OF THE SUSPECT MATERIALS SAMPLED ON THE INTERIOR OF THIS STRUCTURE WERE IDENTIFIED TO BE ASBESTOS CONTAINING BY THE LABORATORY.
